# Ukiah Valley Groundwater Basin Watershed Plan

May 2024

Sustainable Groundwater Management Watershed Coordinator Program

Ca. Land Stewardship Institute

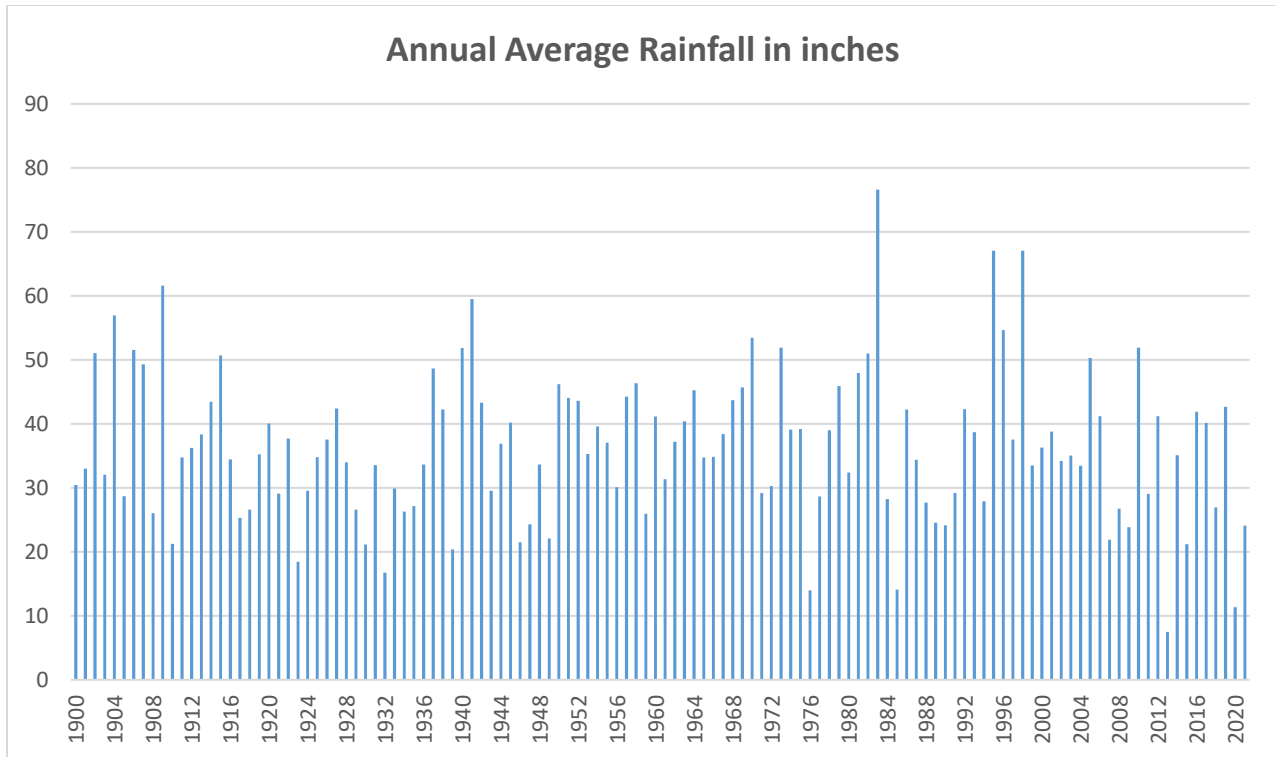
**Figure 7. Average annual rainfall 1900-2020 as measured at Weather Station 00023275, Ukiah Municipal Airport.**

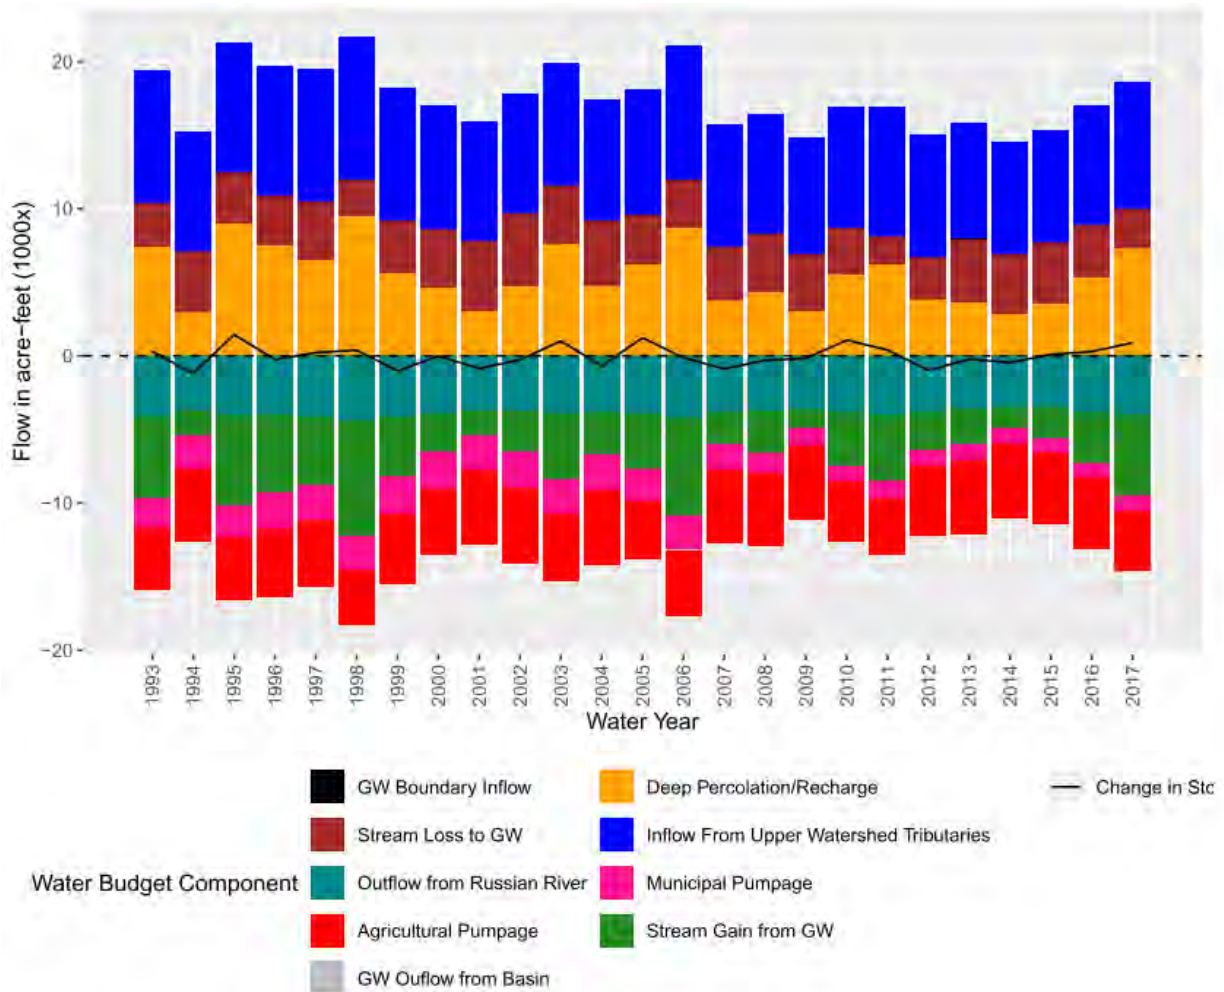
Figure 15. Ukiah Valley Basin Groundwater Budget by Water Year (UVBGSA 2021)

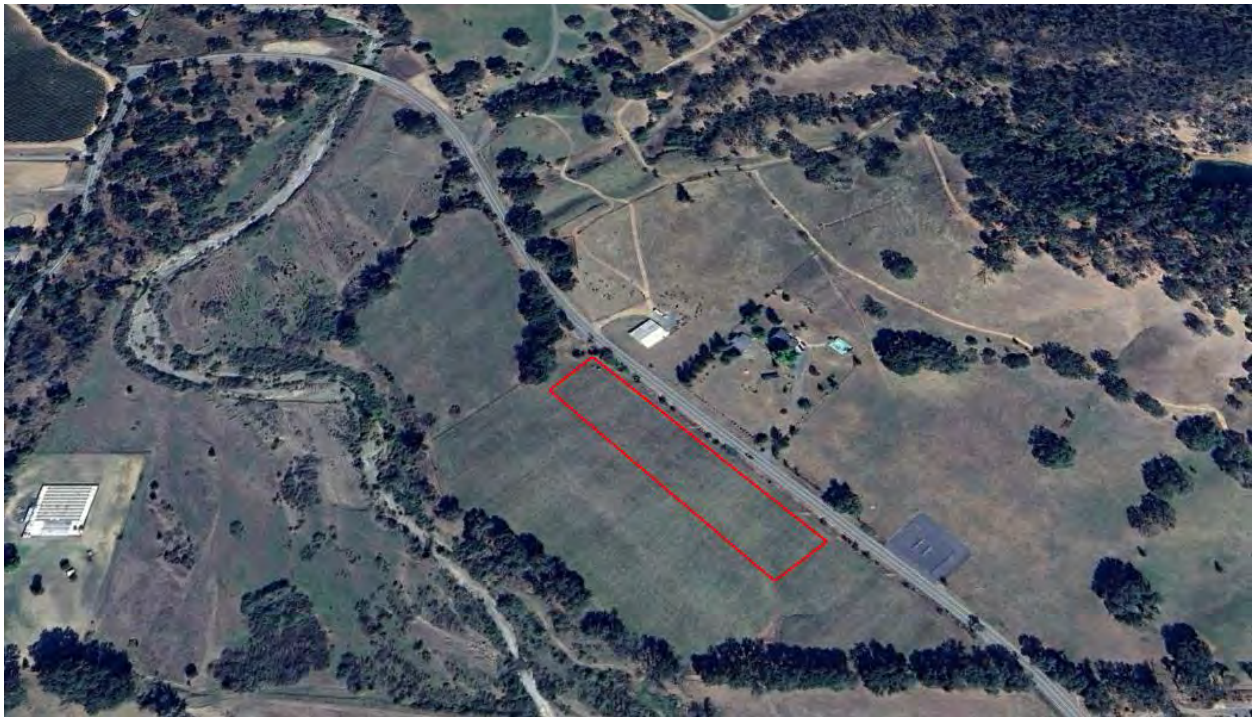
**Figure 32a. Scenario 1 for West Fork Recharge site**

We calculated the number of days needed to fill the pond at a 5 cfs diversion rate for 24 hour/day. Table 9 lists the flow levels on the West Fork Russian River for various frequency flow events. The 2-year frequency flow is 1080 cfs. This is the 50% frequency flow and most likely to occur each year. A 5 cfs diversion was chosen to evaluate the availability of water to fill the pond. A number of hydrological evaluations will be needed to finalize the diversion rate and to determine if the diversion would cause any problems for downstream diverters or instream flows needed for fish and aquatic life.

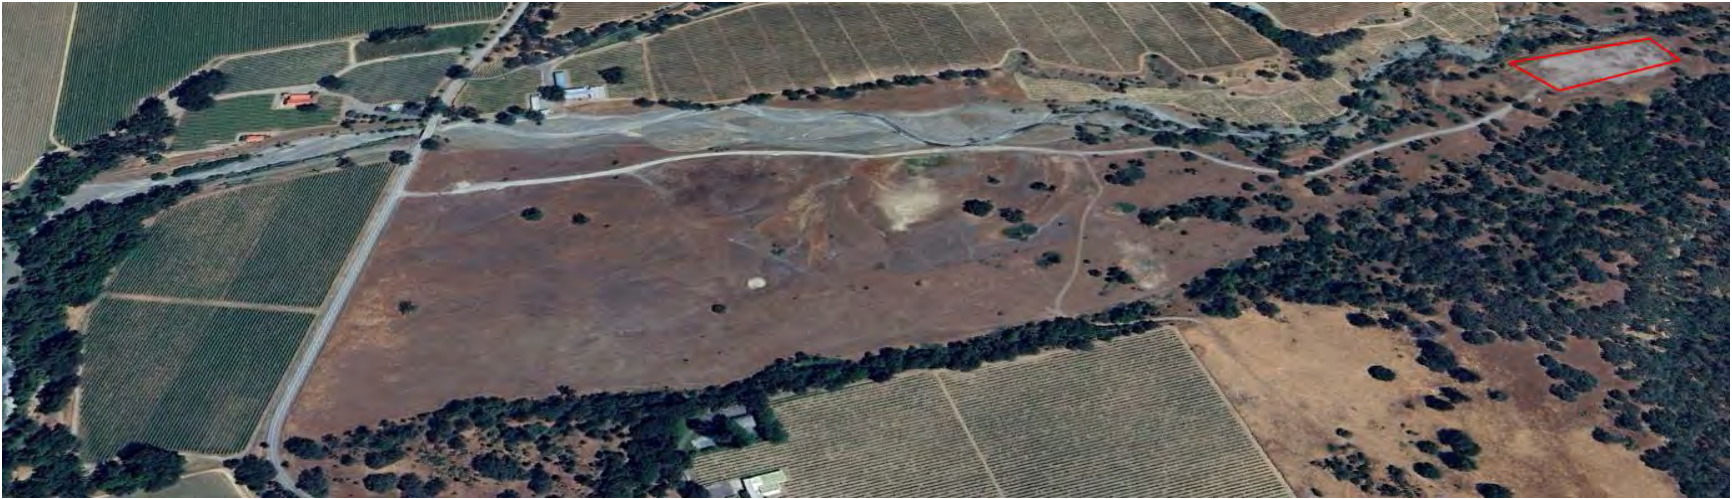
**Figure 33a. Scenario 1 for Morrison Creek Recharge site**

We calculated the number of days needed to fill the pond at a 5 cfs diversion rate for 24 hour/day. Table 9 lists the flow levels on Morrison Creek for various frequency flow events. The 2-year frequency flow is 573 cfs. This is the 50% frequency flow and most likely to occur each year. A 5 cfs diversion was chosen to evaluate the availability of water to fill the pond. A number of hydrological evaluations will be needed to finalize the diversion rate and to determine if the diversion would cause any problems for downstream diverters or instream flows needed for fish and aquatic life. Scenarios 2 and 3 also offer the option of filling the pond from the mainstem Russian River.

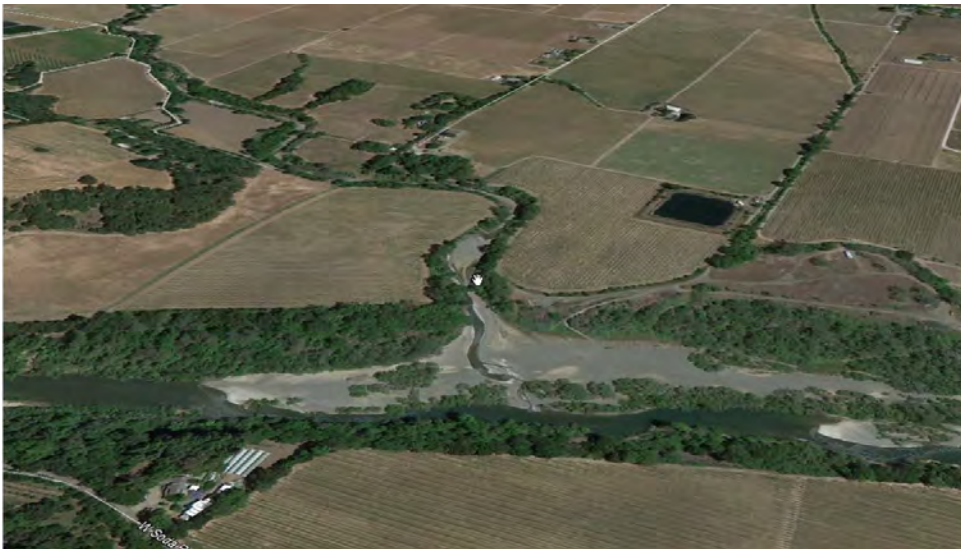
**Figure 37. Unconfined alluvial channel**

On the floor of Ukiah and Redwood Valleys, creek channels are unconfined with little to no large rock to affect the course of the creek (Figure 37). These creeks have floodplains where storm water overtops banks and spreads out. These channels meander and form gravel bars and pools.

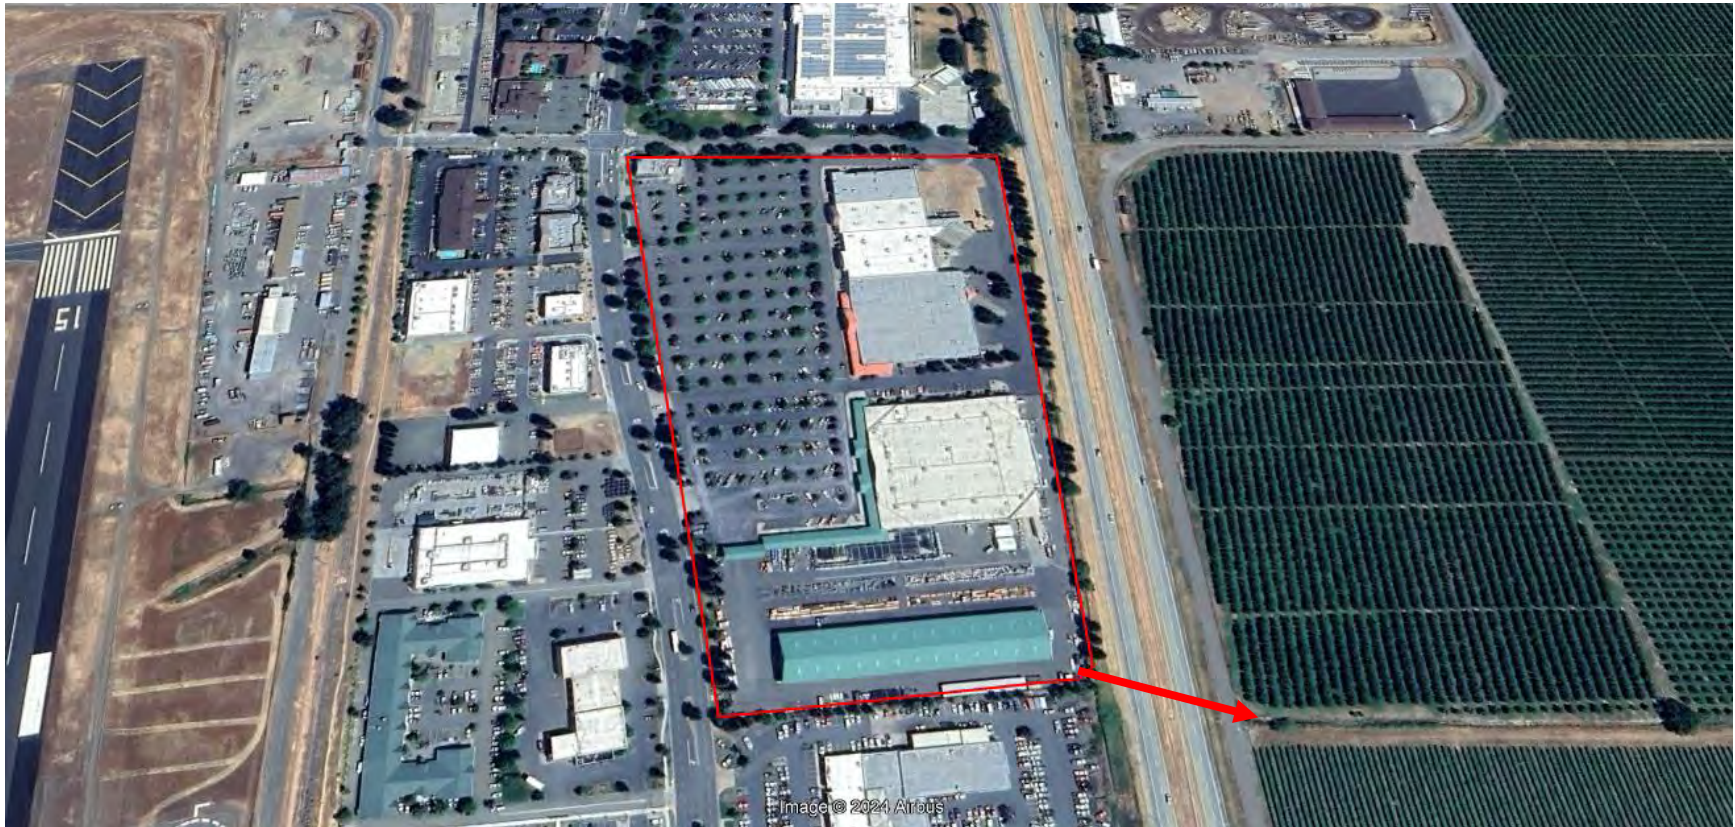
**Figure 184. Parking lot with direct discharge of stormwater and no filtration**
